Re: Rule 26 Report of Findings
File: Marberger v. Nivens (SEFC# 241017.4)

Introduction

Description of the Incident

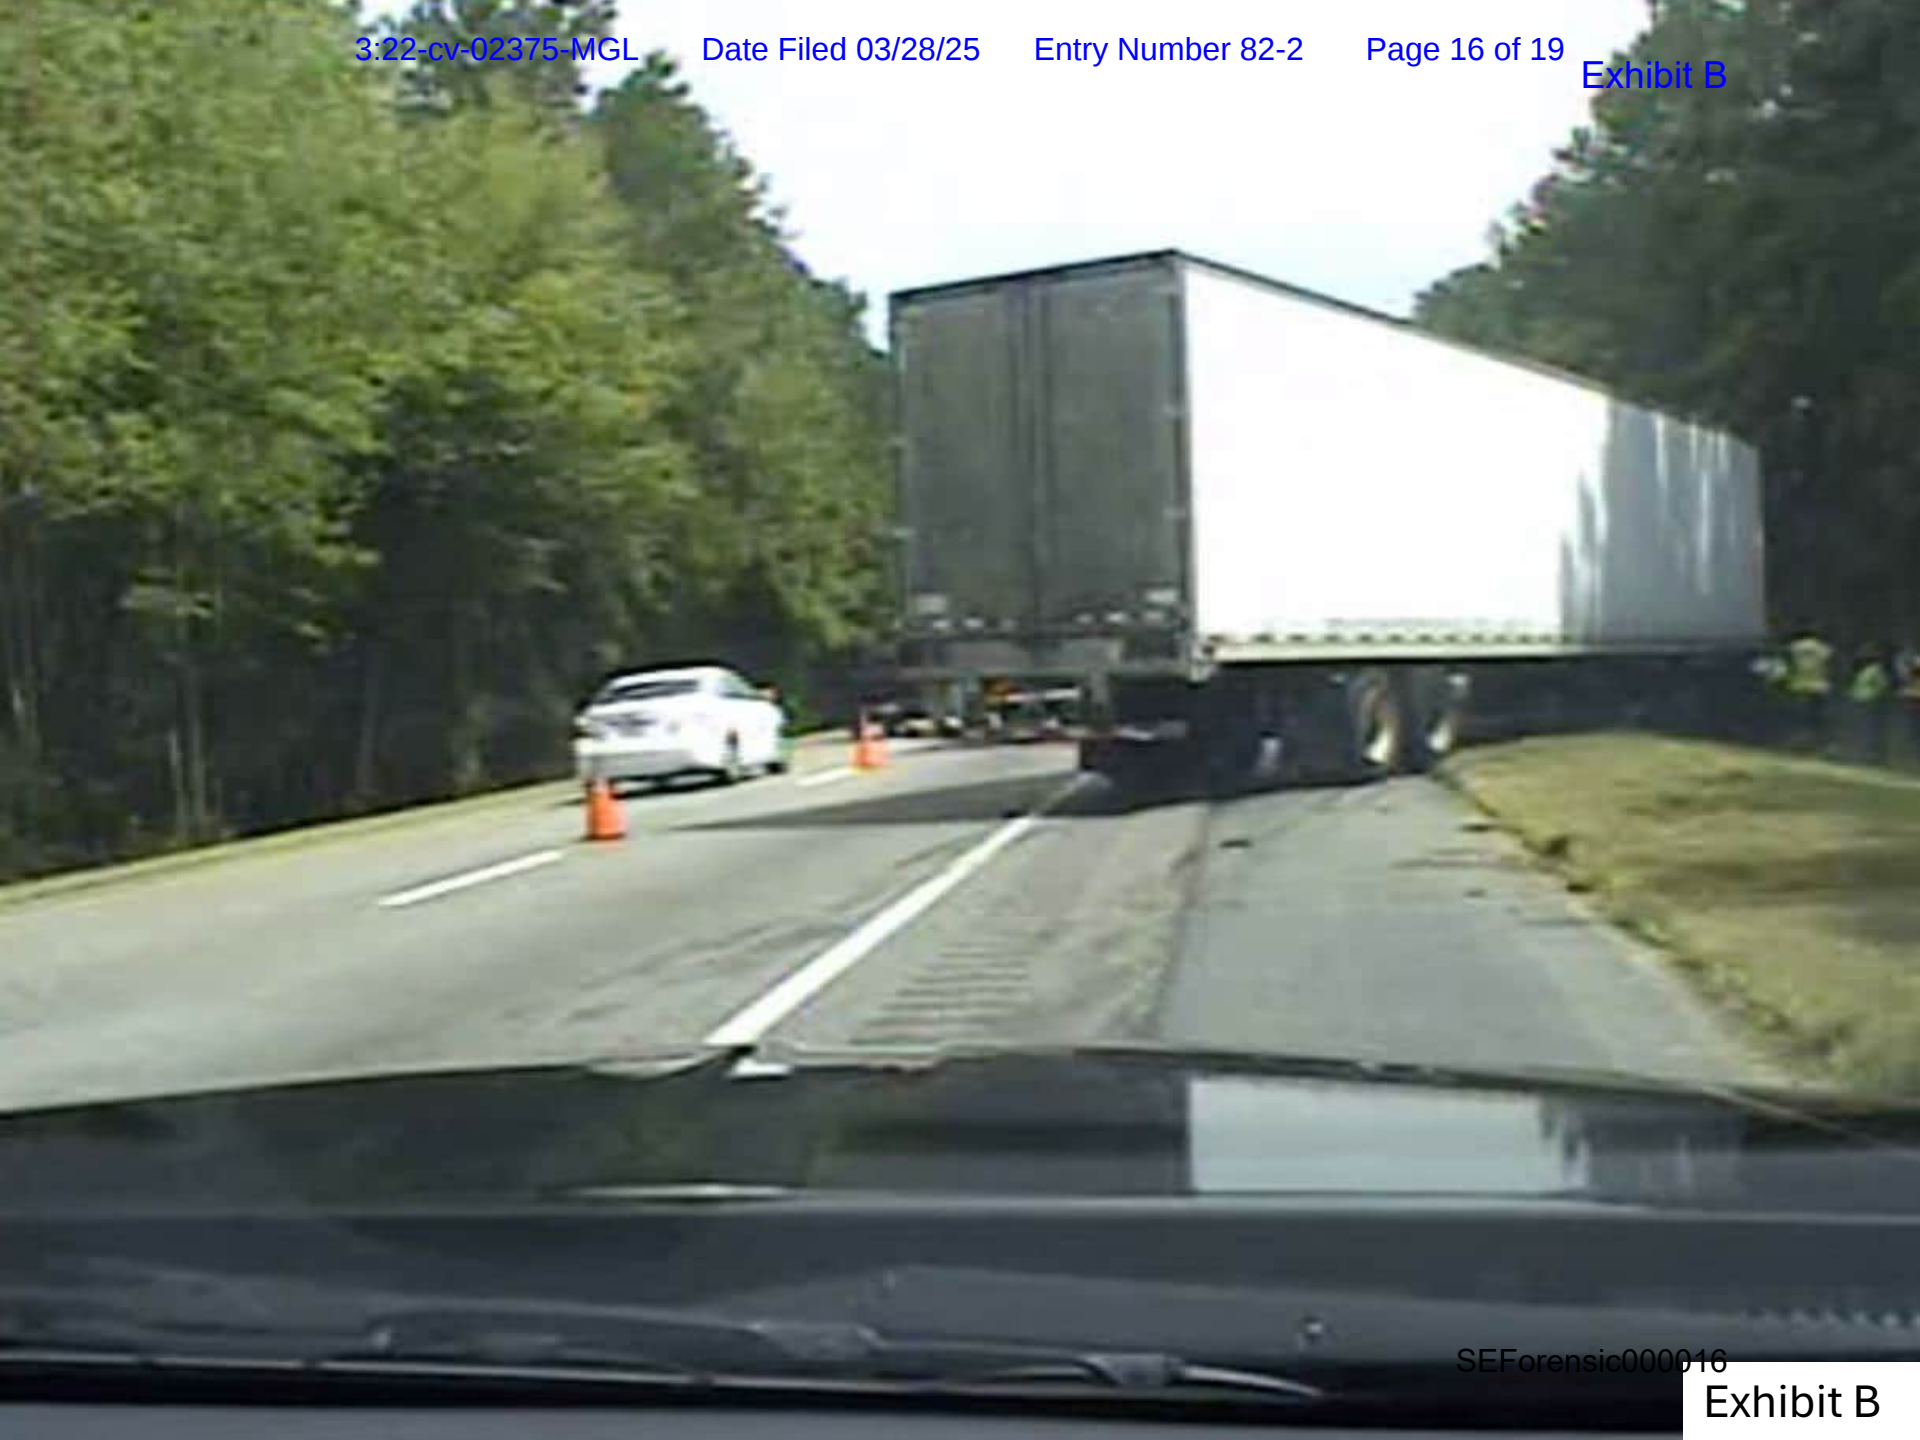
SE Forensic000015

The dash camera footage documents the responding officer's investigative efforts at the scene. The following observations were based on our review of the video:

- The dash camera footage shows the white Peterbilt tractor trailer at its point of rest. The tractor trailer is jackknifed partially on the road and partially off the road.

- An image from the dash camera footage has been attached as **Exhibit B**.

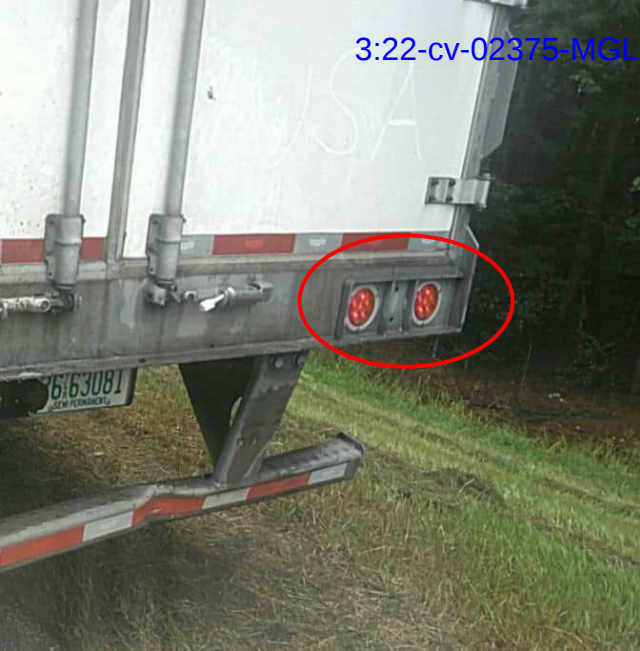
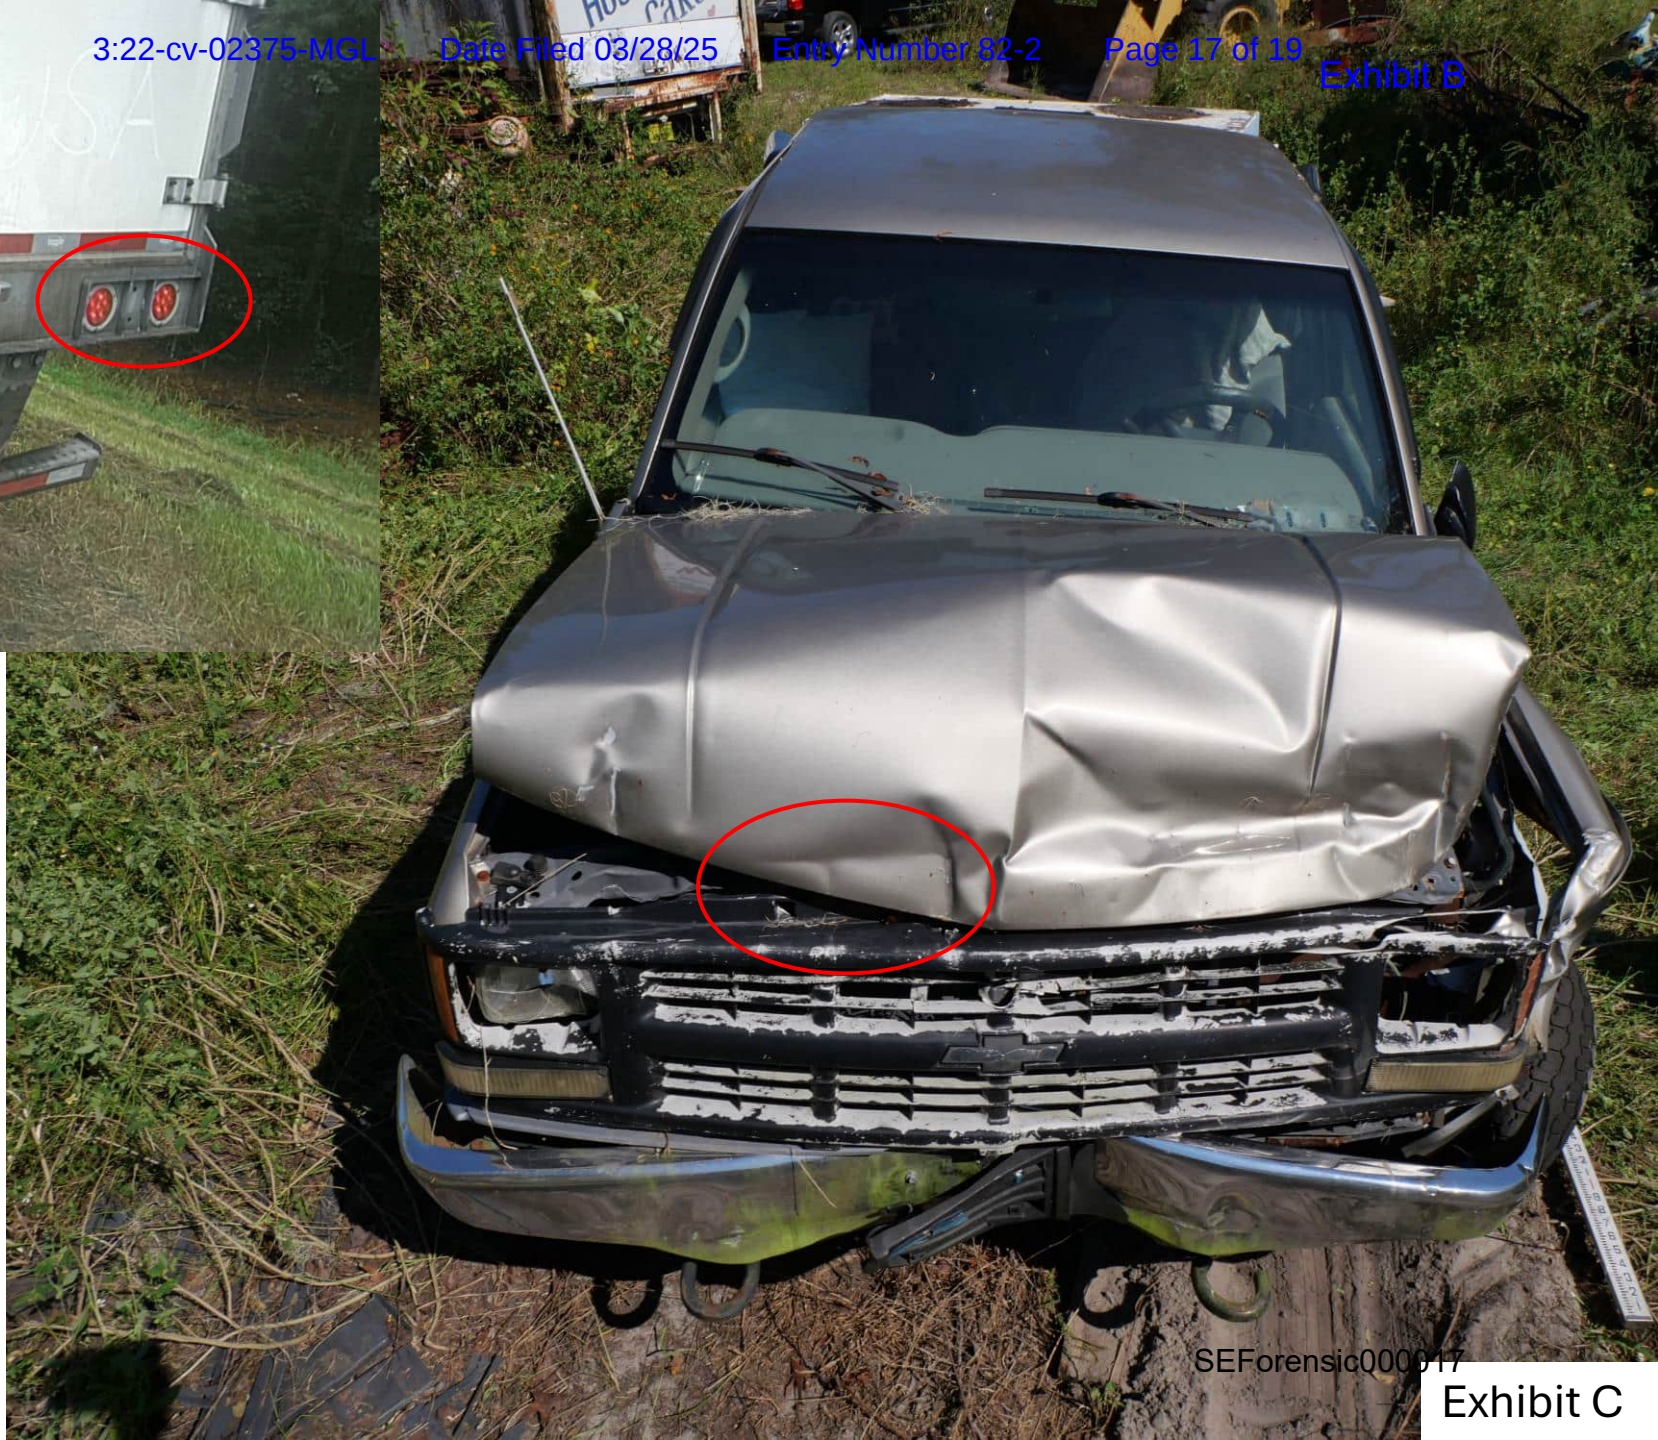
Exhibit C

- The driver side of the Chevrolet was mainly undamaged with the exception of the front fender and front tire de-bead.
- The front of the Chevrolet had a stamp mark which is consistent with an impact to the horizontal and vertical light protection on the rear of the tractor trailer. (**Exhibit C**)

- There are no offset stamp markings or crush areas in the front of the Chevrolet.
- At the time of my inspection, the passenger side of the front bumper had been pulled away from the tire, closer to its pre-impact location.

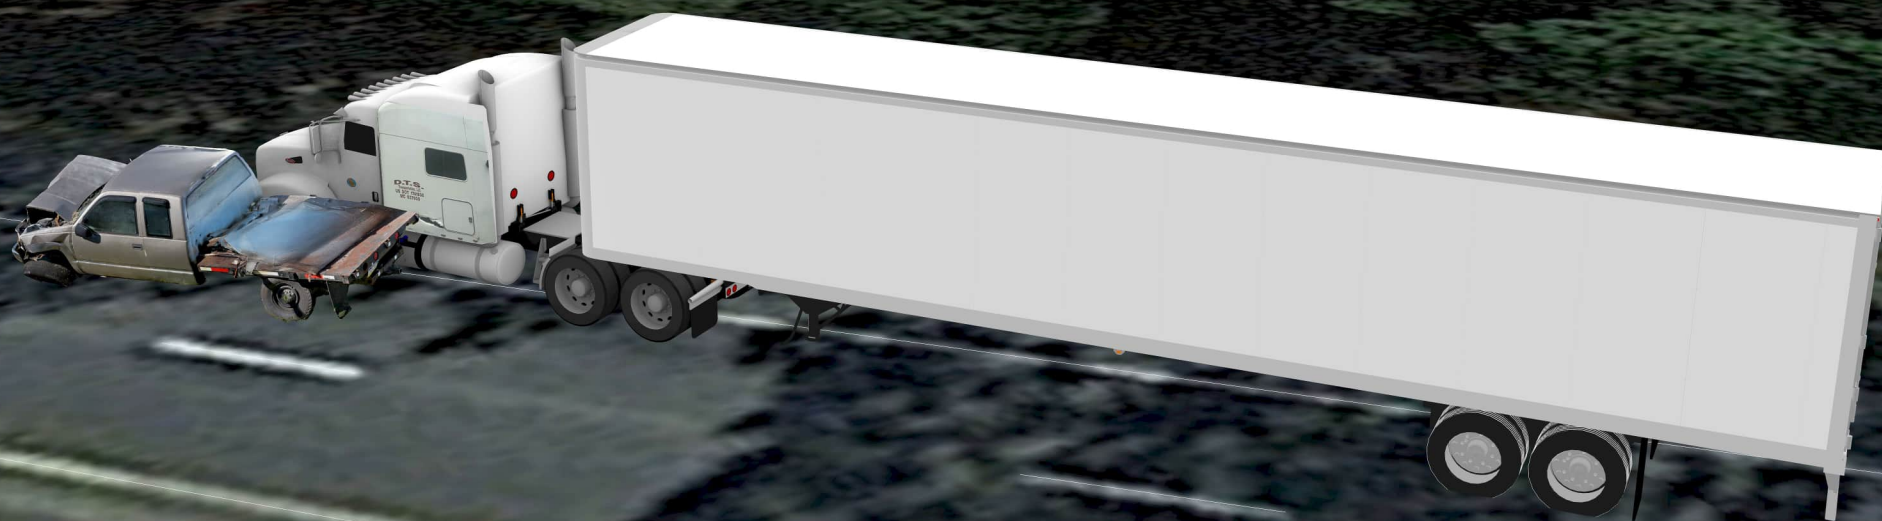
Conceptual Diagram

- There are two different characteristic markings on the passenger side of the gold Chevrolet.
 - The first set is at approximately the same height as the rub rails on a tractor's trailer and are near horizontal, consistent with the sideswipe incident discussed by the officers in the dash camera footage.

- The second set of markings are near the bottom of the cab and slant upwards and towards the front of the Chevrolet. These are likely the result of the larger rear impact when the white Peterbilt under rode the Chevrolet, damaging the suspension, and displacing the rear axle forward.

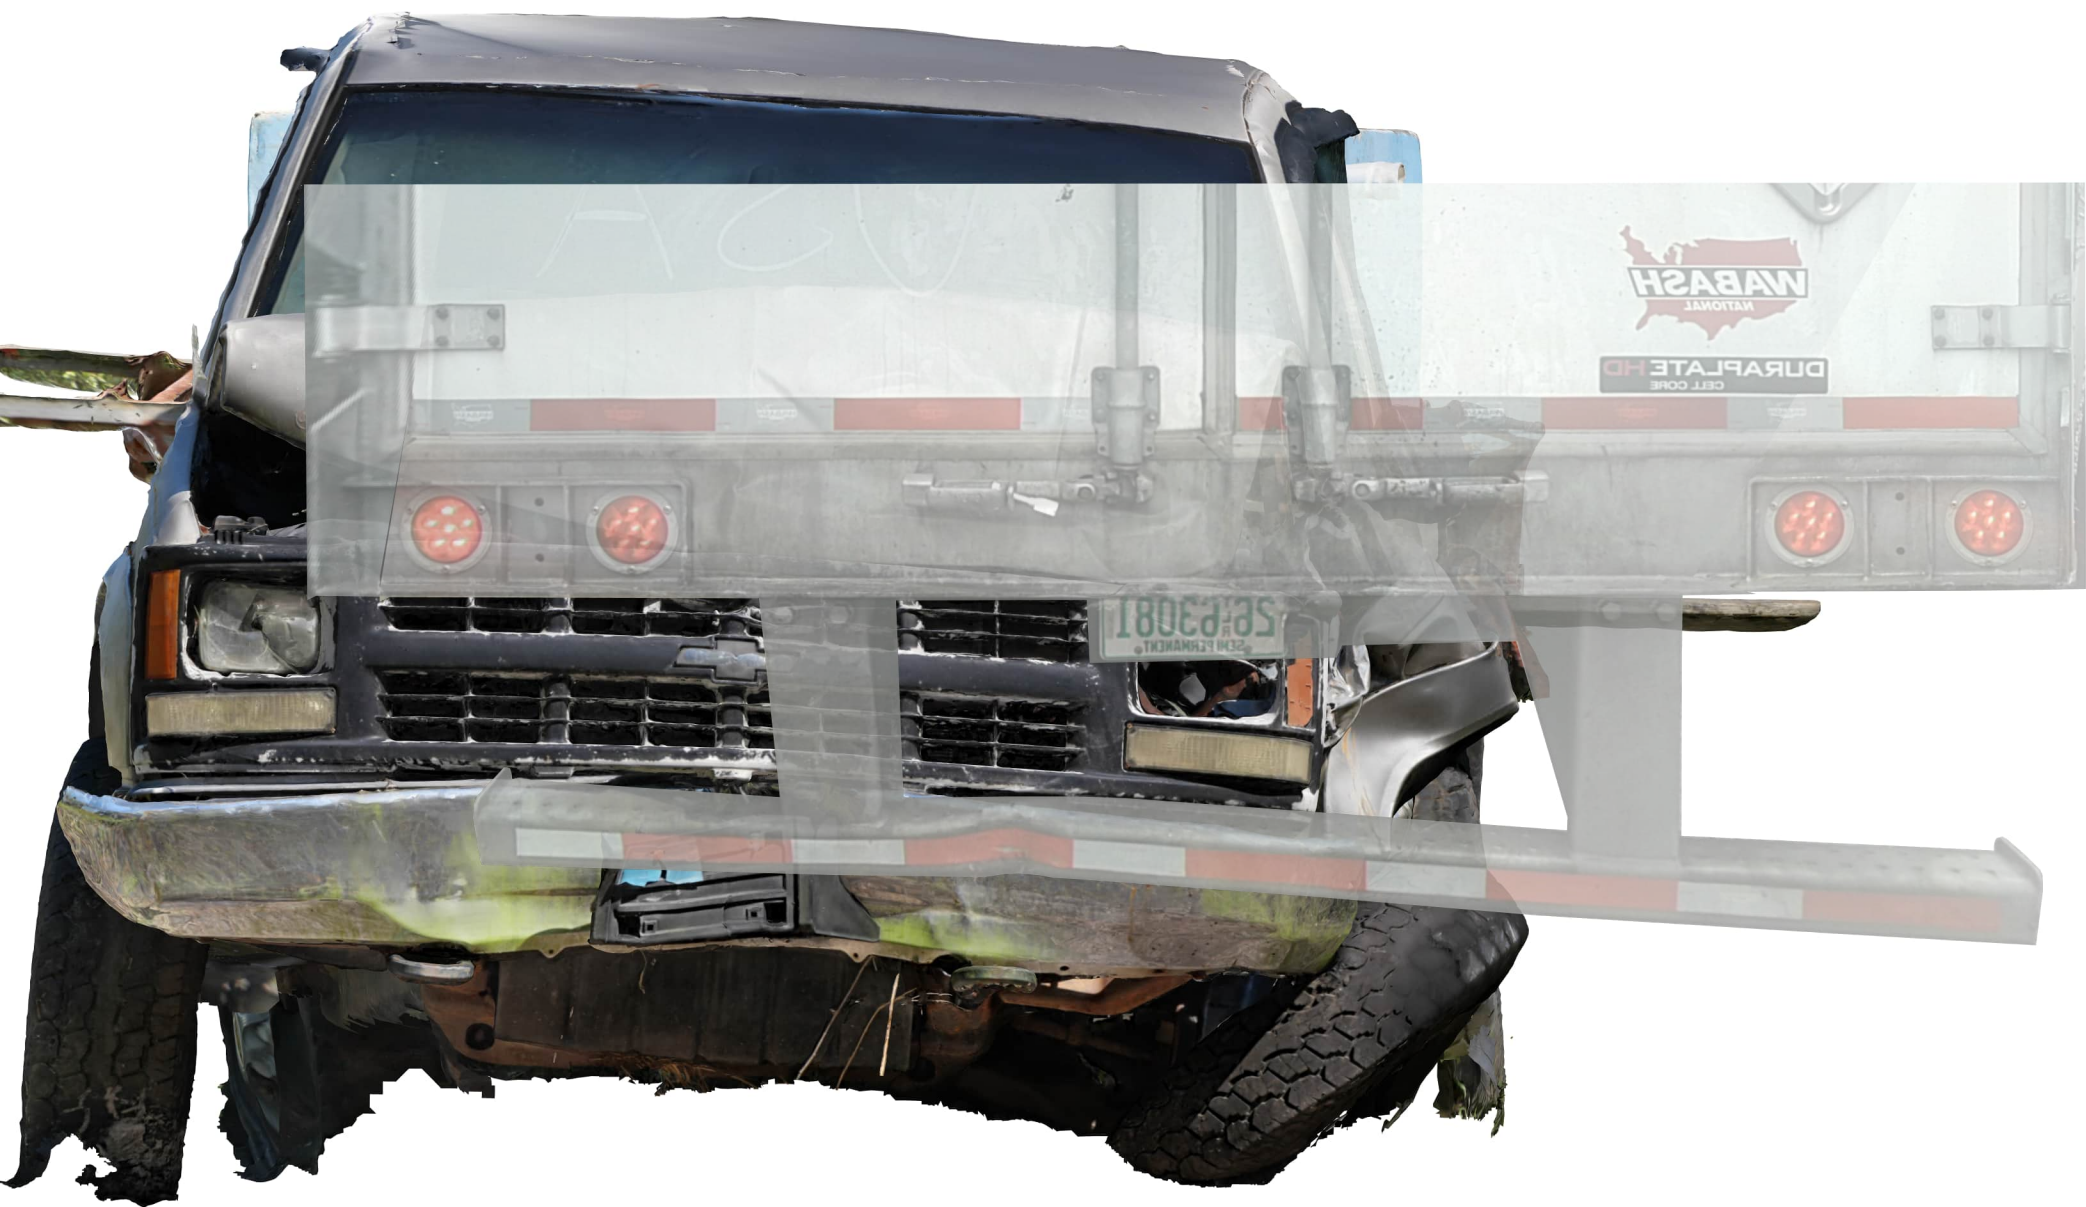
Exhibit D

- A crush analysis was used to calculate crush energy, equivalent barrier speed, and maximum crush force. Crush analysis is an application of the law of conservation of energy.
- A momentum analysis was used to determine the closing speed (the difference in speed between the two vehicles). Momentum analysis was also used to determine the ΔV (change in speed) of the vehicles. Conservation of momentum is a principle derived from Newton's laws of motion. Momentum is proportional to vehicle velocity times vehicle weight.
- Kinematic equations were used to calculate the pre impact velocity of the white Peterbilt. Using post impact travel distance from scale drawings, drag factors, pre impact speeds can be determined.
- Scaled 3D diagrams and images were created from point clouds, meshes, and imagery taken on the date of the incident. Two examples are attached as **Exhibit D & E**

- The white Peterbilt was traveling approximately 30 mph at the time it rear-ended the gold Chevrolet which propelled the gold Chevrolet into the rear of the green International.

- The closing speed of the gold Chevrolet into the green International was between 15-20 mph, causing the gold Chevrolet to have a near 15 mph ΔV .
- If the white Peterbilt had maintained a safe following distance and been attentive, there would have been ample time to stop before colliding with the gold Chevrolet.
